Subject: Department of Natural Resources Washington Geological Survey,  
School Seismic Safety Assessment Project, Contract No. AE 410 -  
Seismic Evaluation for **Camas School District**

**Table 1-3. Identified Structural Seismic Deficiencies for Camas Lacamas Heights Elementary School 100 Pod**

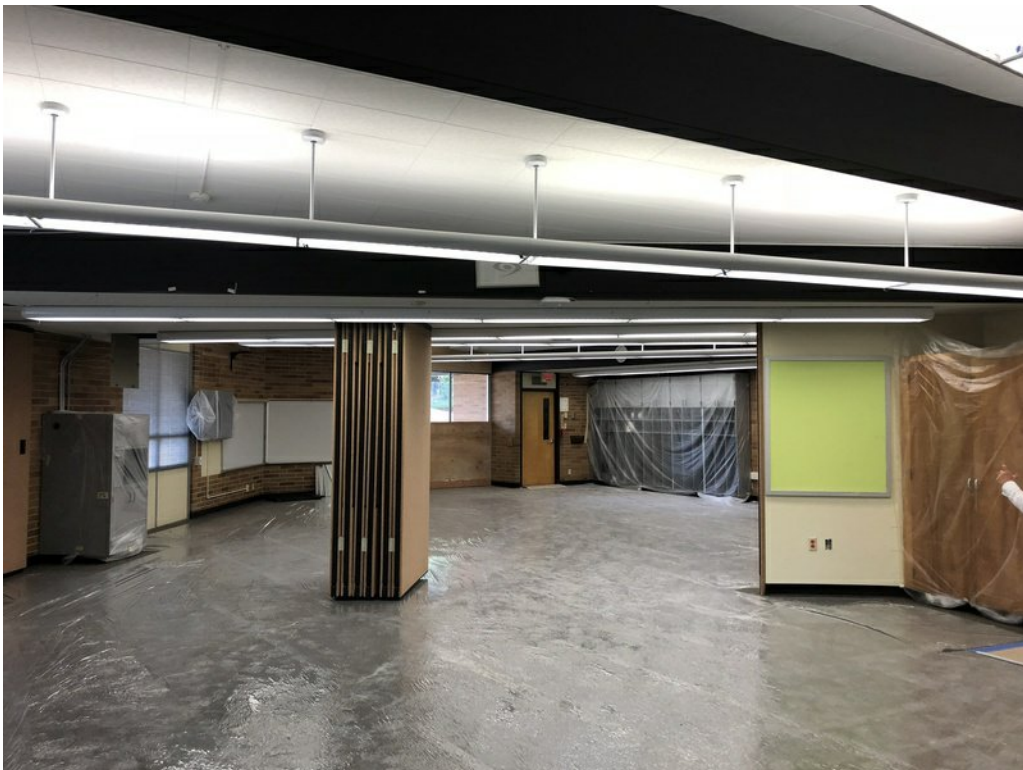
**Figure 1-4. Classroom 108/109 with Moveable Partition**

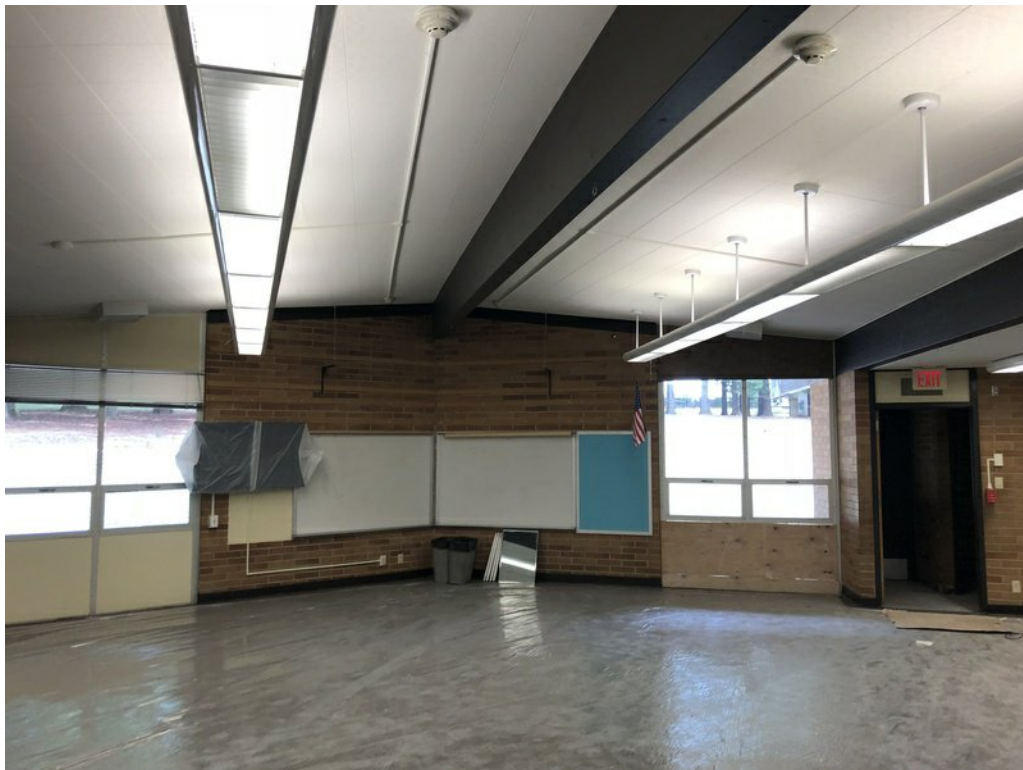
**Figure 1-6. Classroom 108 with Unreinforced Exterior Masonry Walls**

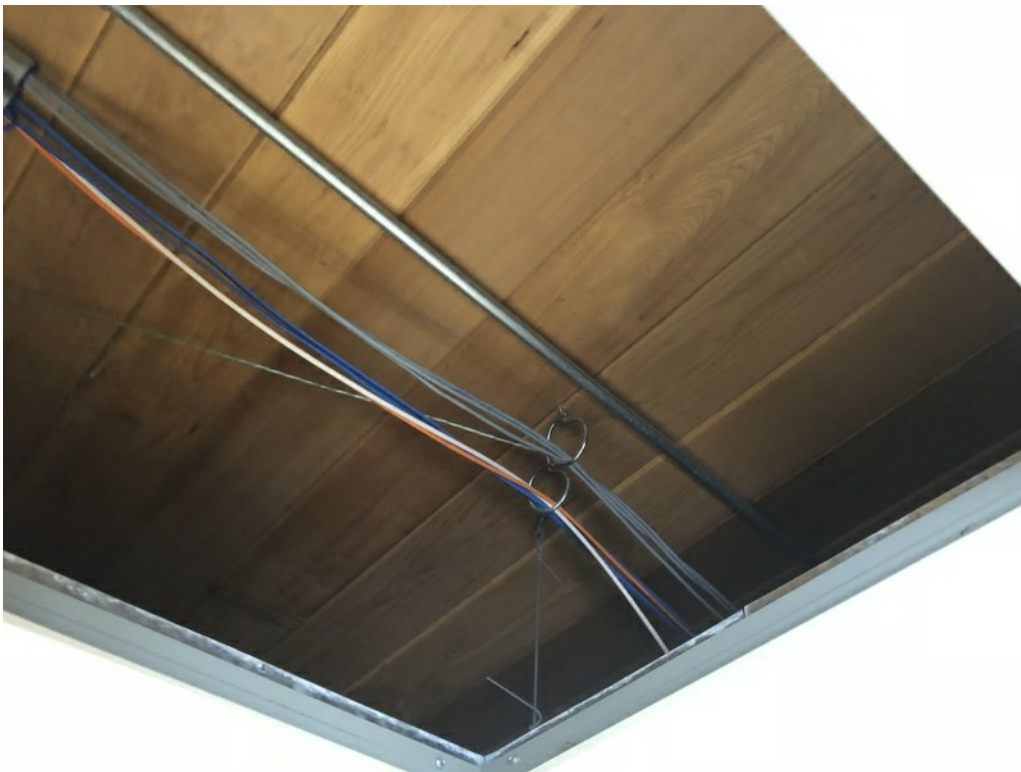
Figure 1-8. 4x Decking Typical at Roof

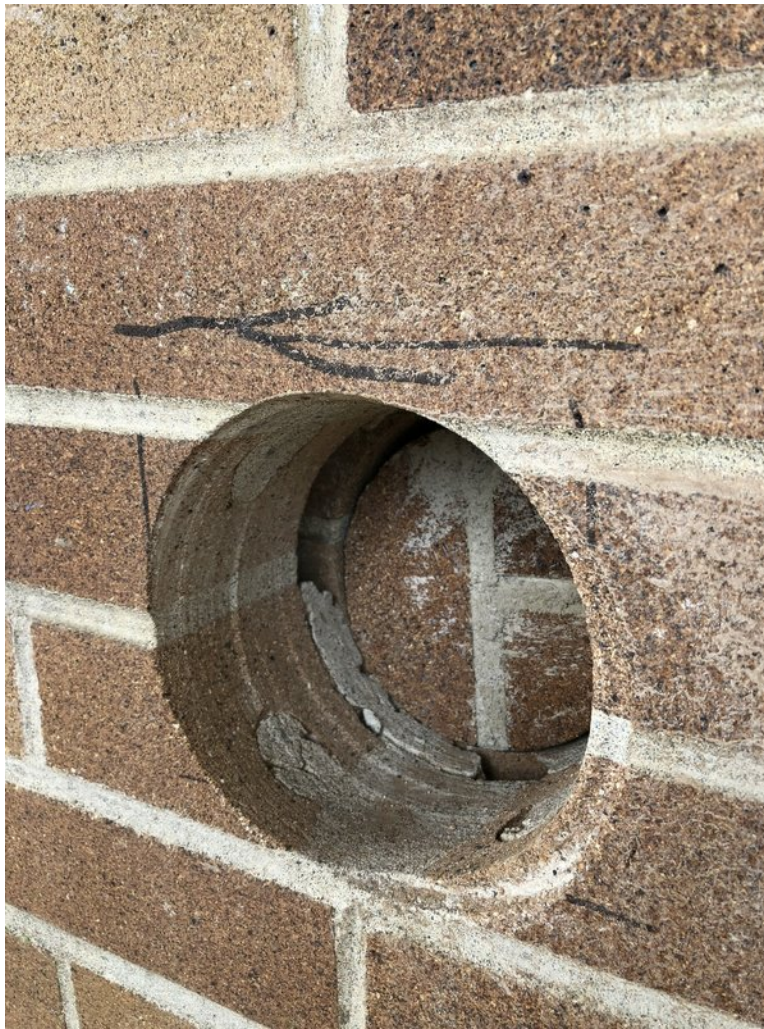
**Figure 1-10. Exterior Double Wythe Masonry Wall with Mortar Gap**

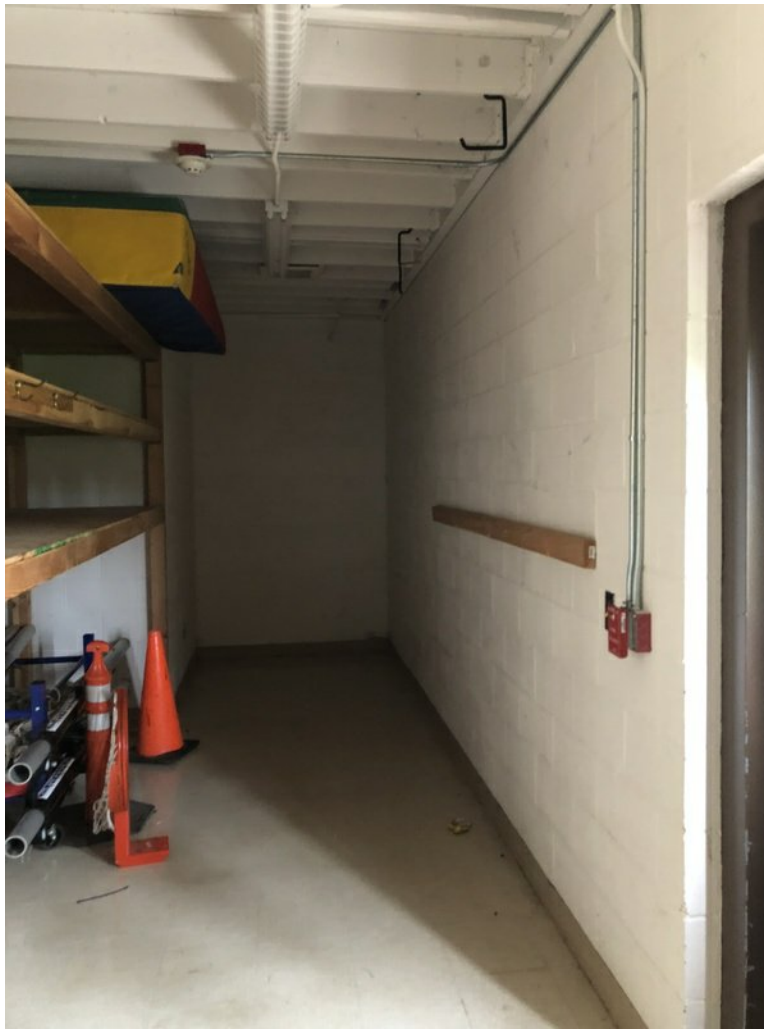
**Figure 1-6. Storage Space with Mezzanine at East End of Multipurpose Room Addition**

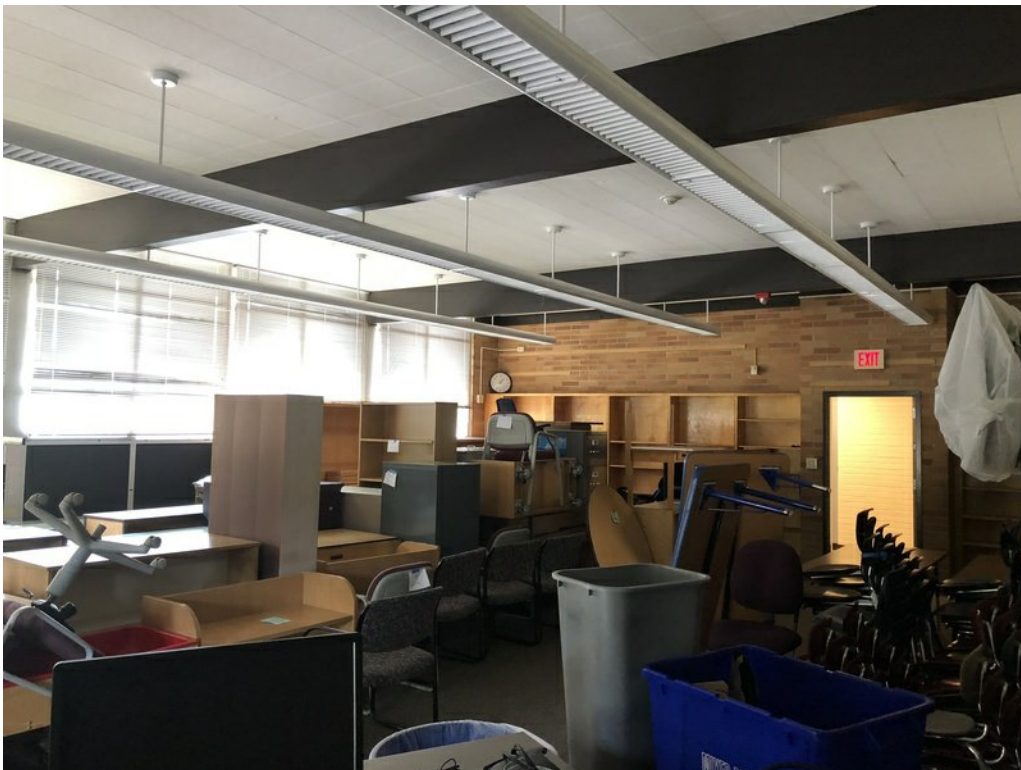
**Figure 1-8. Full-Length Wall of Windows in Library. Likely Has Insufficient Lateral Strength.**

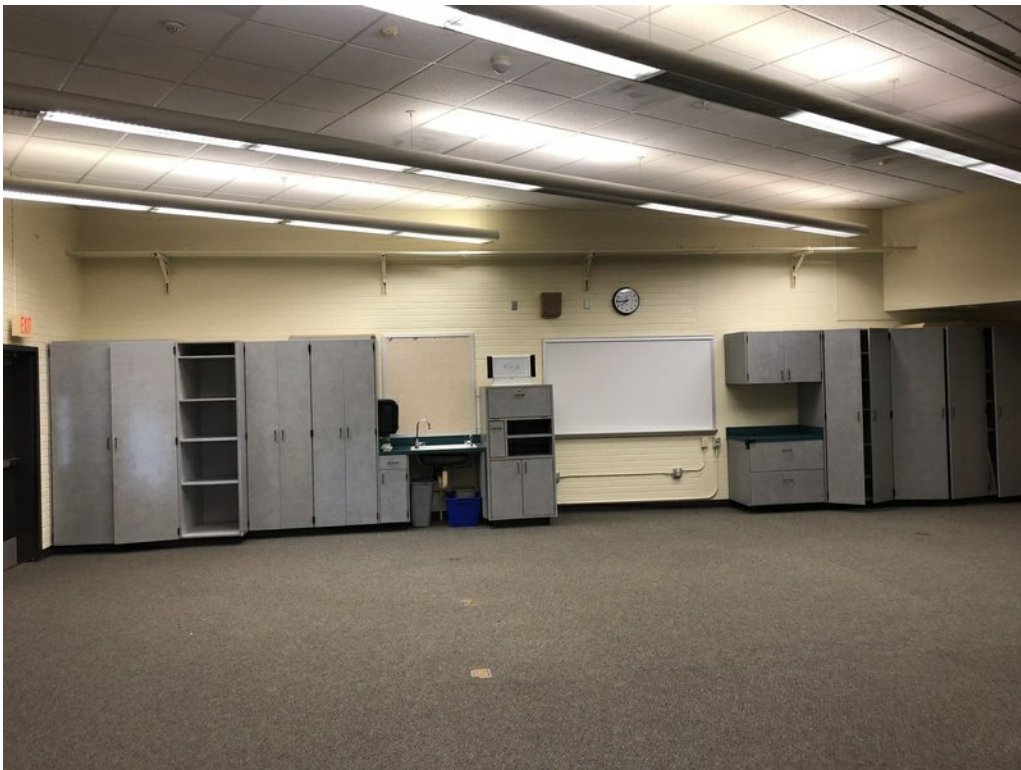
**Figure 1-10. Large Unbraced Cabinets Typical Throughout**

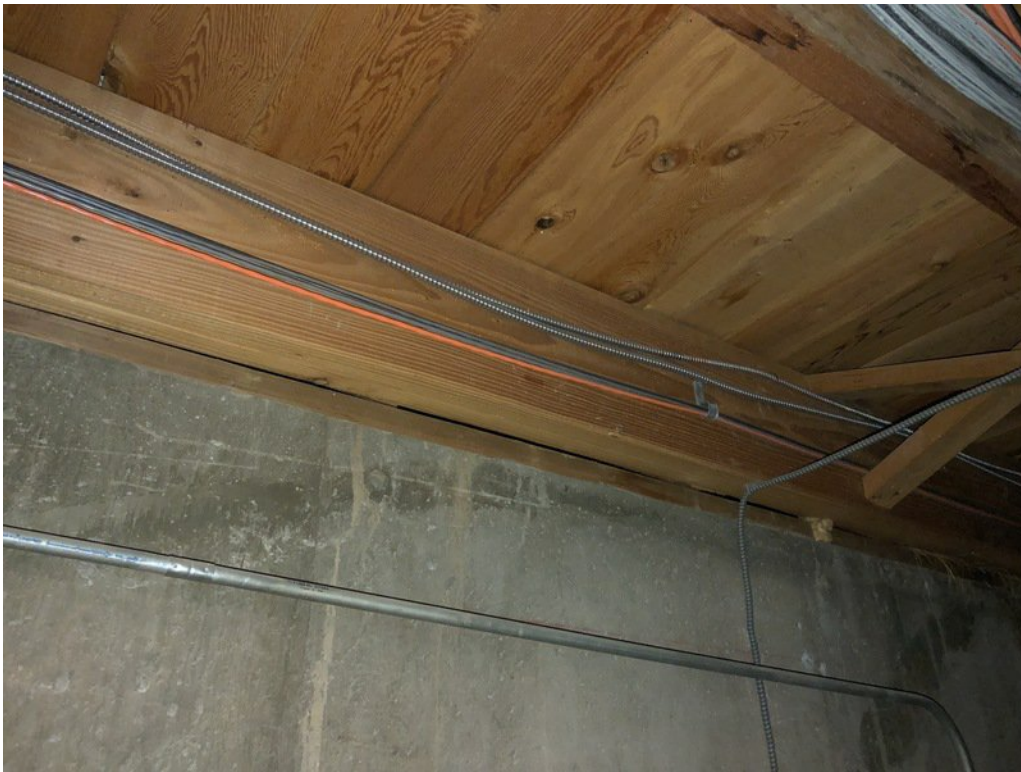
**Figure 1-5. Straight Sheathing, Typical**

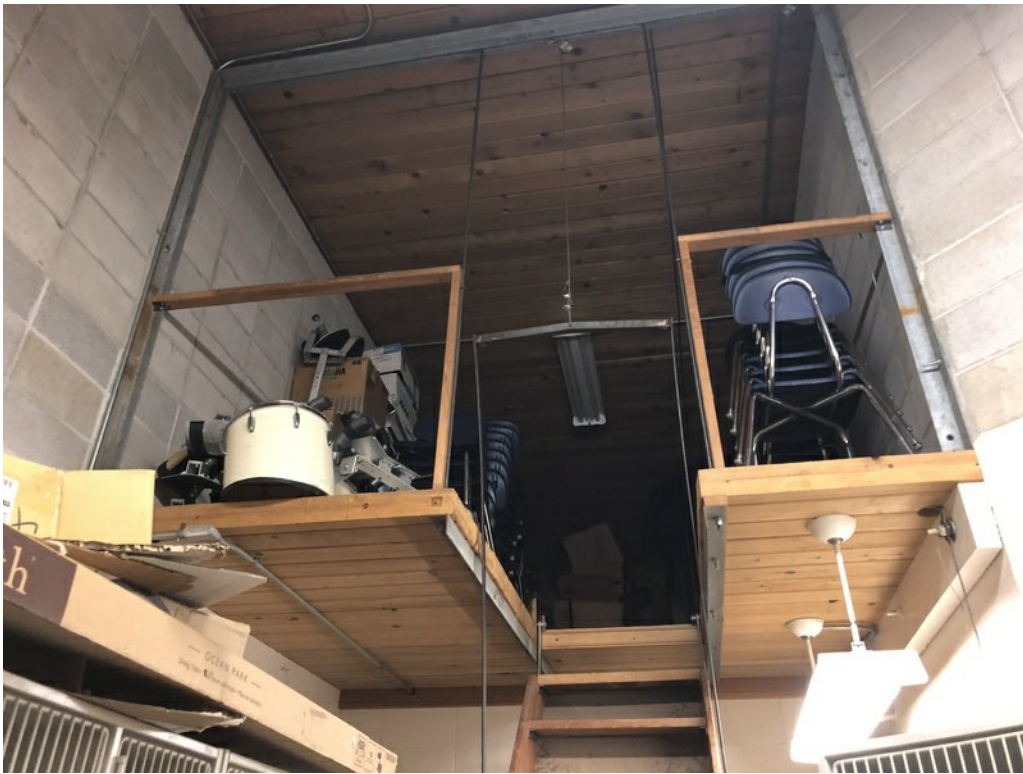
Figure 1-5. Wood-Framed Mezzanine

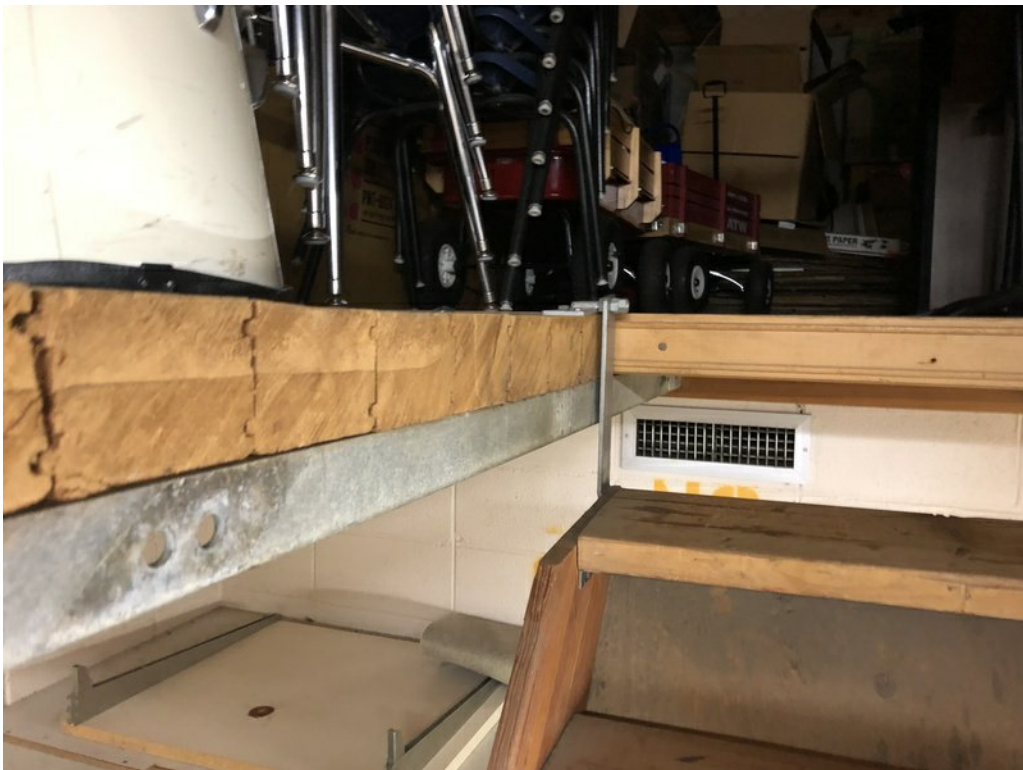
Figure 1-6. 4x Decking Diaphragm at Mezzanine

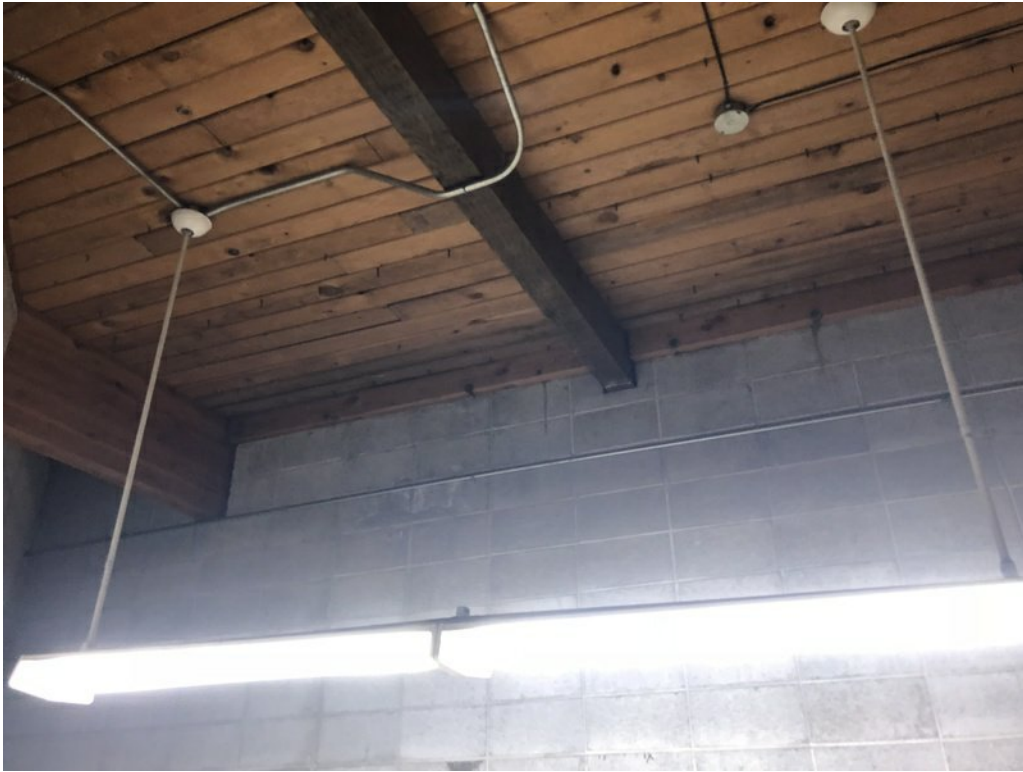
**Figure 1-7. Straight Sheathing over Glulam Beams, Typical**

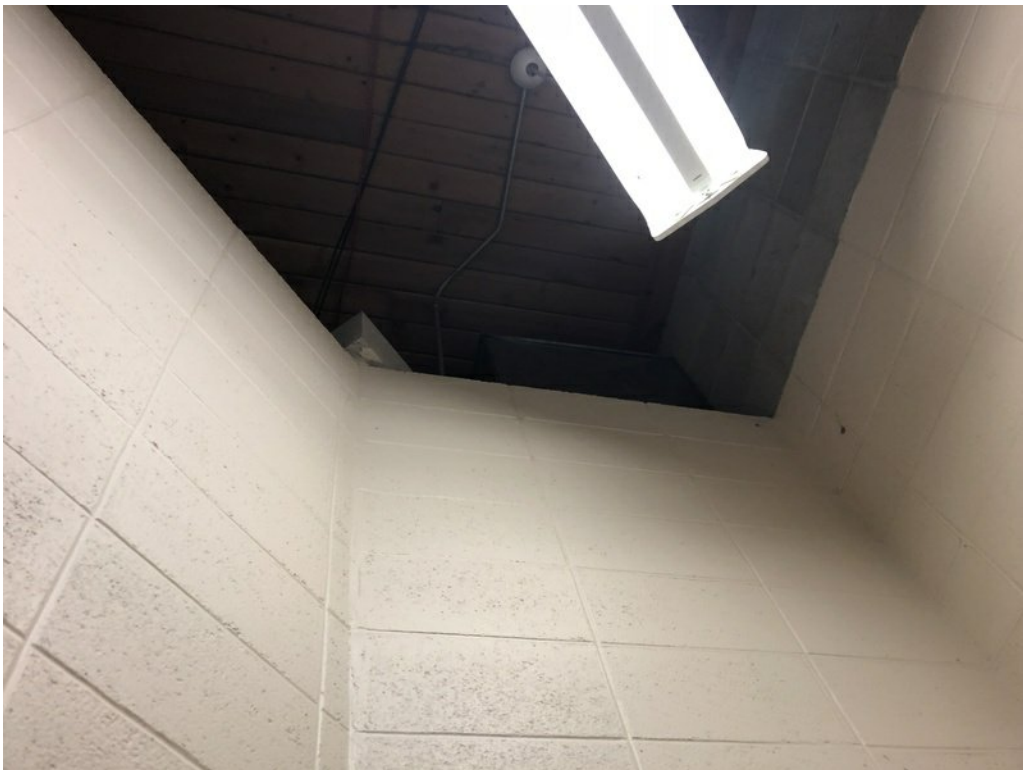
**Figure 1-8. Masonry Wall Unbraced at Top**

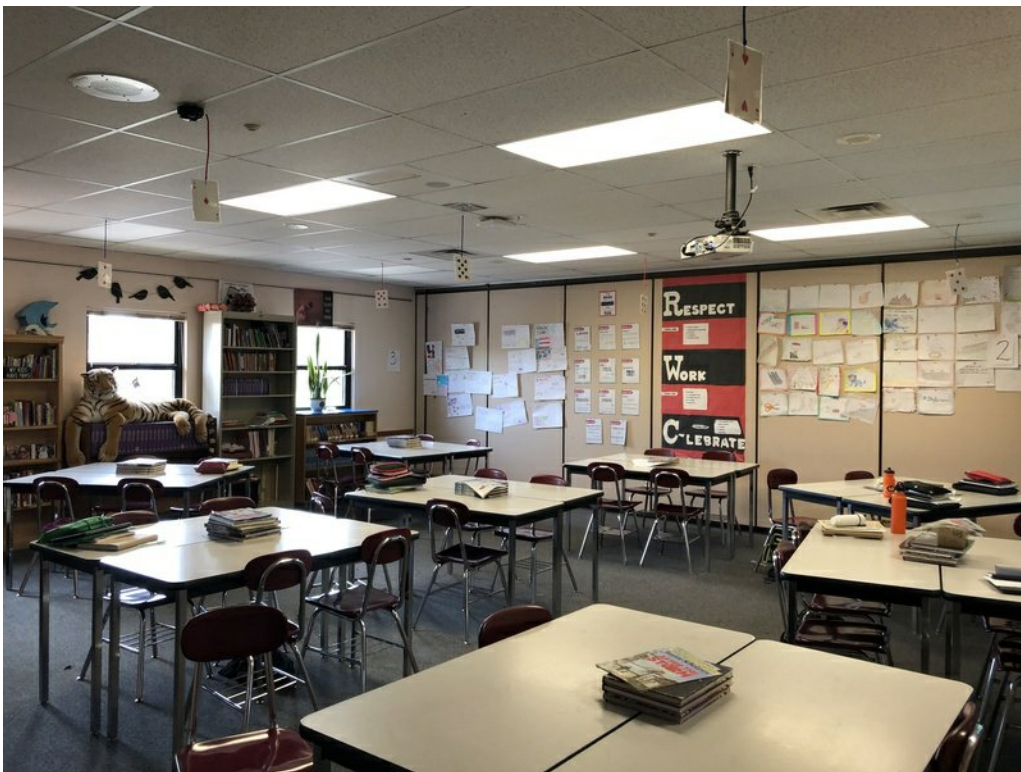
Figure 1-4. Typical Classroom with Unknown Bracing of Light Fixtures

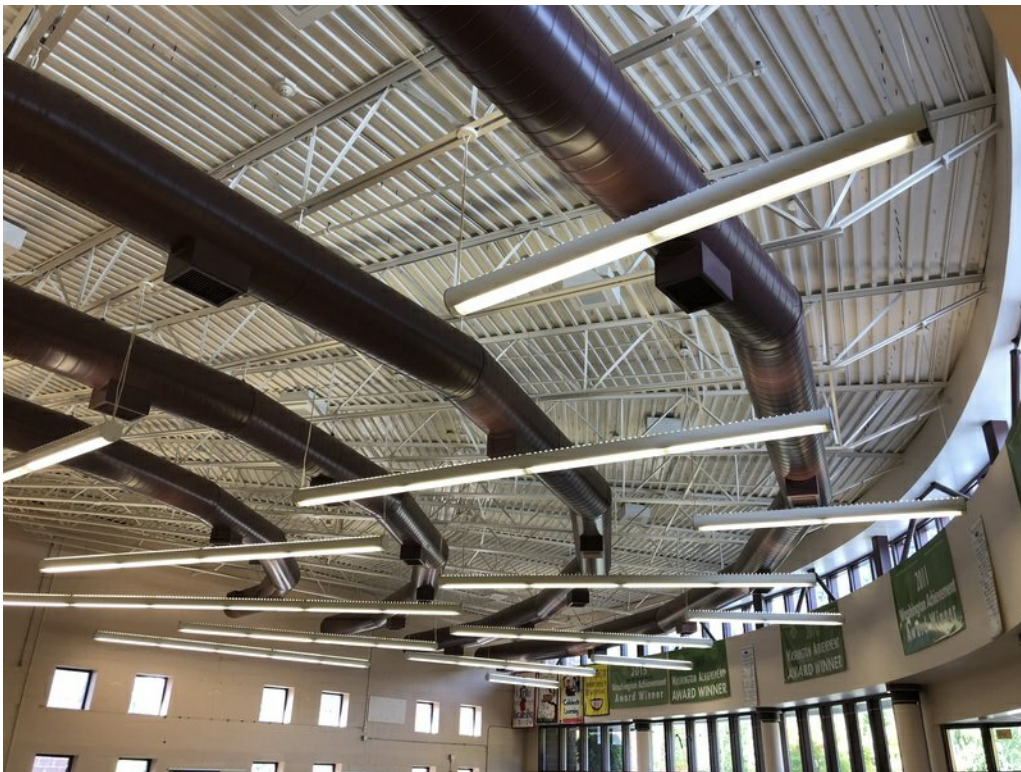
Figure 1-6. Commons Roof Framing, Steel Bracing, and Unbraced Ducts at Windows

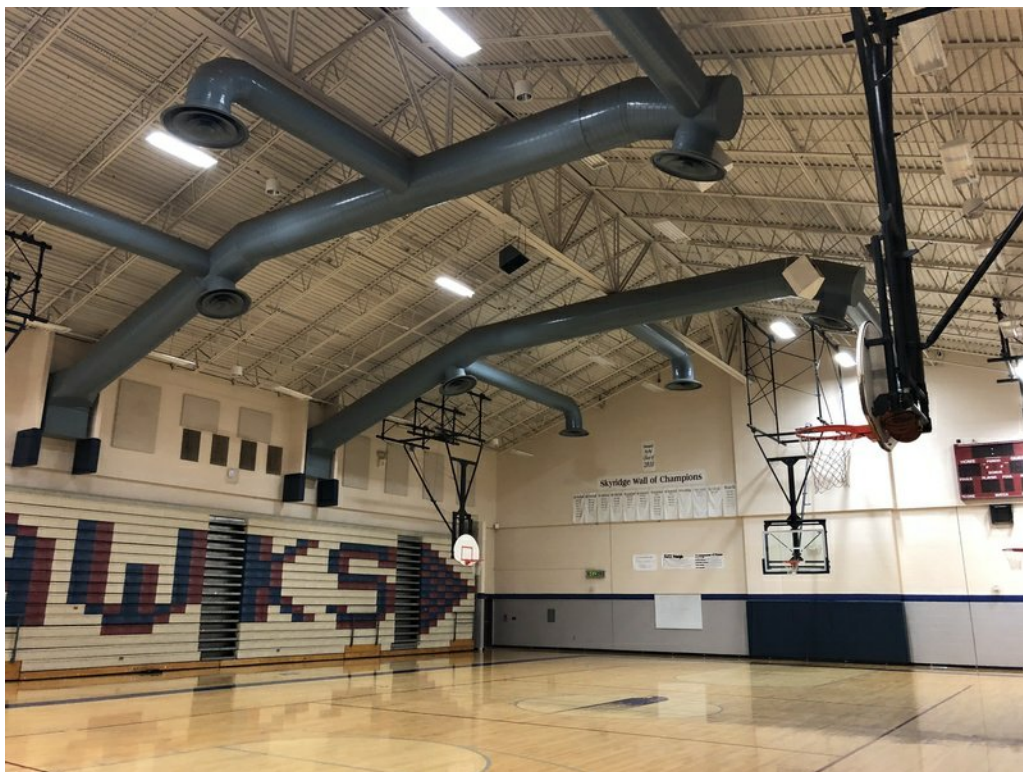
Figure 1-8. Gymnasium with Metal Roof Deck Over Steel Joists

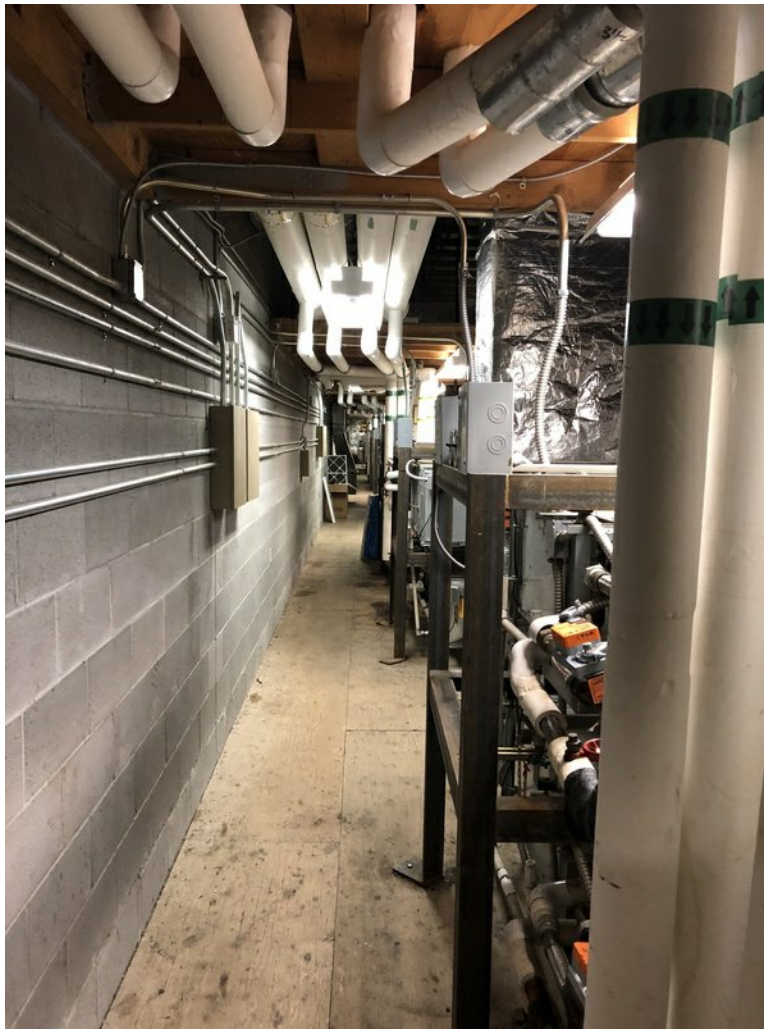
**Figure 1-9. Wood-Framed Mechanical Mezzanine and Masonry Wall without Out-of-Plane Anchorage**

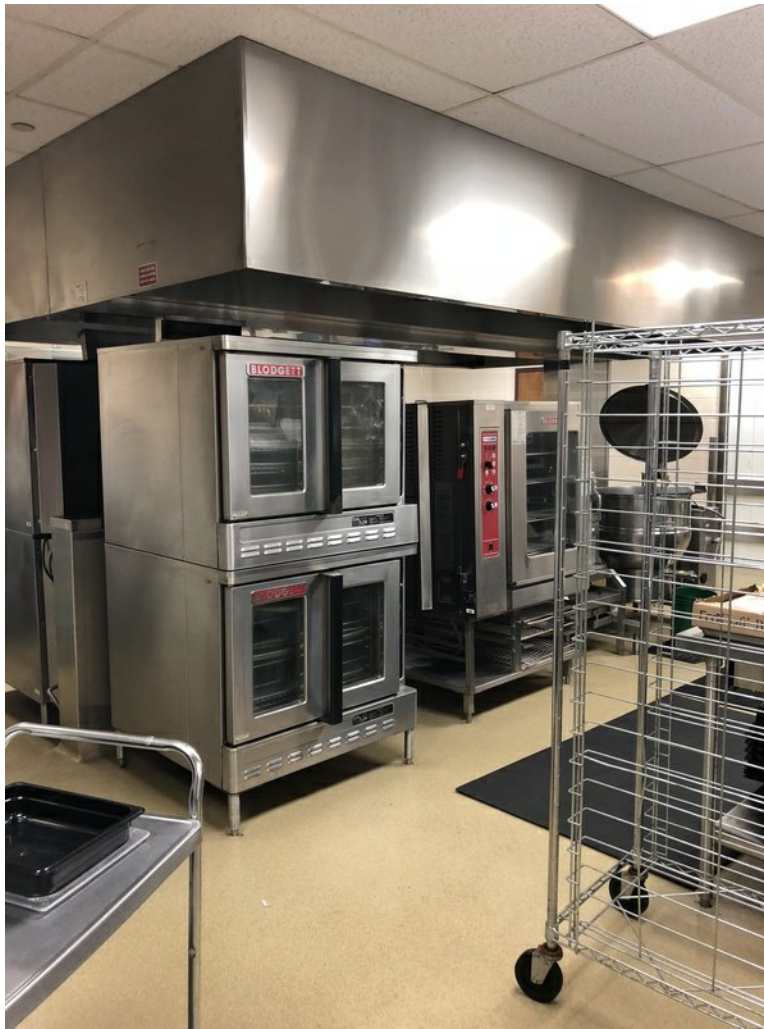
**Figure 1-10. Kitchen - Tall Unbraced Nonstructural Components, Typical Throughout**
